Capital Programme Review 2018-19

Project Appraisal Form

Playhouse - Replacement of stage floor surface

EPSOM PLAYHOUSE STAGE FLOOR SURFACE

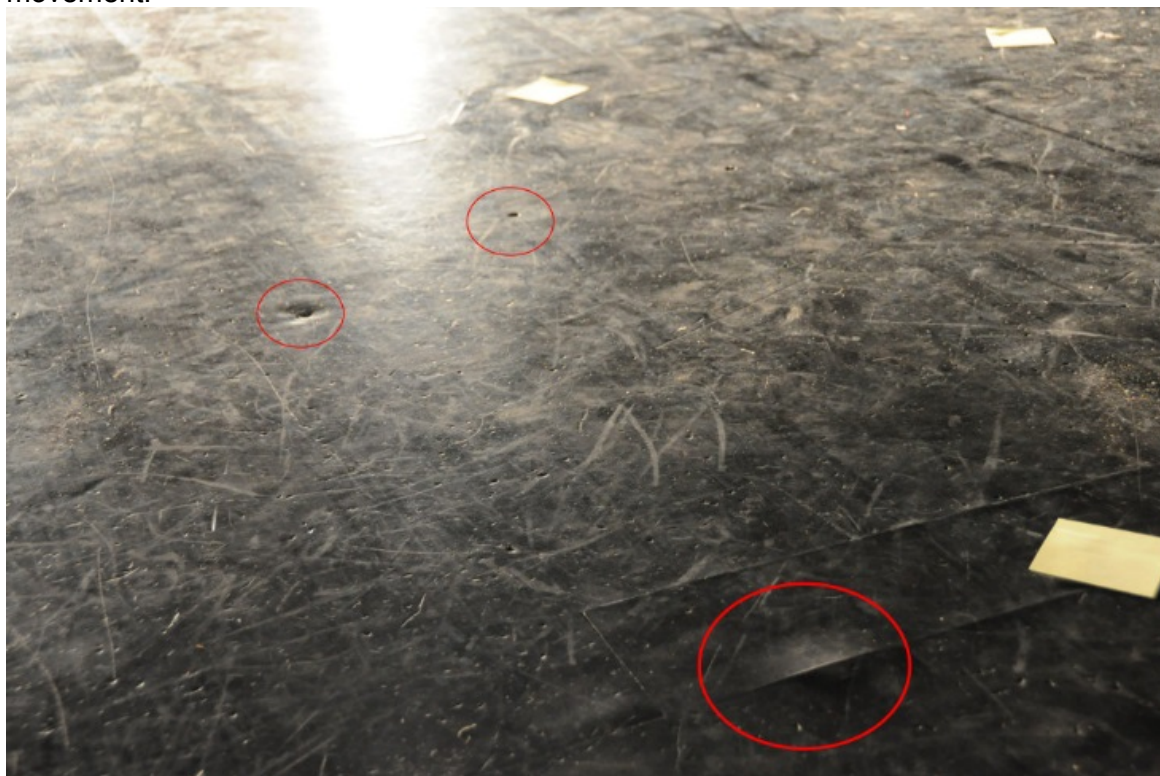
Where the vinyl lifts along its seams it creates a trip hazard for dancers in bare feet or soft shoes. Other damage to the floor creates small holes where the vinyl is missing and although these holes are only around 10mm across and 2mm deep, they can be enough to 'unsettle' or even trip a dancer in their movement.

In the first picture above, it can also be seen that previous repairs are now starting to need attention for a second time (the seam lift nearest the camera is on an existing patch)

The problems are exacerbated by the condition of the underlying floor structure. The nailing holding the planks to each other and to the joists that support them has worked loose, allowing more movement of the floor structure than the vinyl can contain. This is the reason for so much seam lifting, as it is the point where the flooring can 'give' with the movement.

Option 1 : Replace the plywood layer and fit new vinyl. This will remove all the patching and associated problems with lifting and holes in the short-medium term. The stage floor should maintain the 'as new' appearance that it will receive for some time. The ply will need replacement as it will delaminate when the old vinyl is removed, leaving an uneven floor surface.

Option 2 : Take the stage floor back to joists and replace the planking with a new double-layer plywood floor, then fit surface ply and new vinyl as above. This is the long-term solution, curing the inherent flexing problem that is lifting the seams, and as a bonus stopping the floor from squeaking as it's moved across.

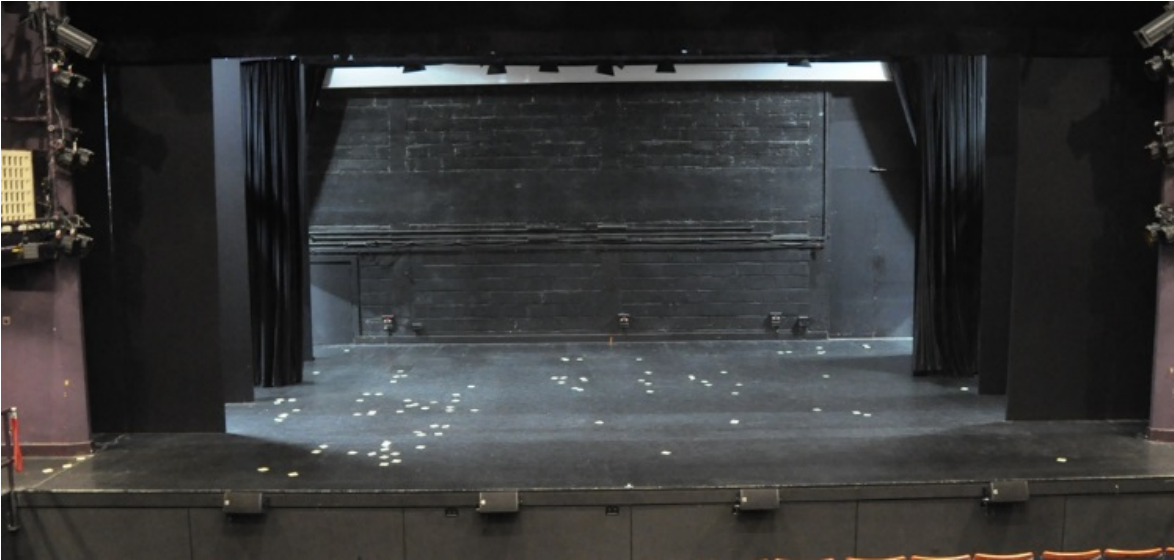
The photo below gives an idea of the scale of the current floor patching; each 'flag' is a past repair, seam lift or hole.

(The picture shows 88 flags, there are some more in the wings areas.)

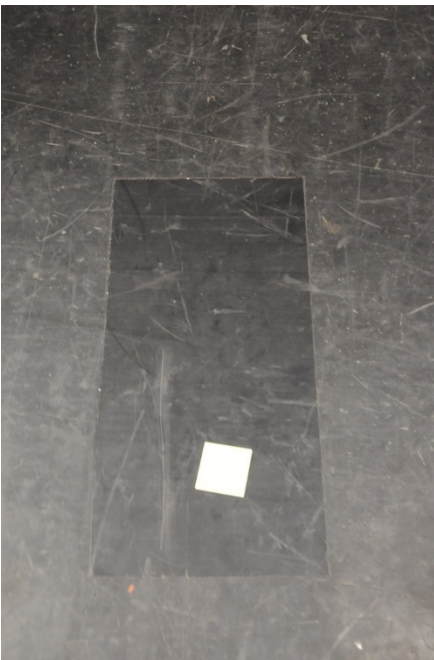
While many of the defects are smaller than the flag marking them above, others are more substantial, the largest being 70x35cm (28x14in) where water ingress occurred at a seam and lifted and distorted a larger area of vinyl.
