Additional Information not included in SLR's Flood Risk and Surface Water Management Statement Version 2 dated May 2022

JACOBS			
CLIENT EPSOM & EWELL BOROUGH COUNCIL			
PROJECT Epsom and Ewell SFRA			
TITLE Historic Flooding			
DRG No Figure 104			
SCALE NTS		DATE 08/05/2018	
CW DRN	MS CHK'D	MS REWD	RC APR'VD

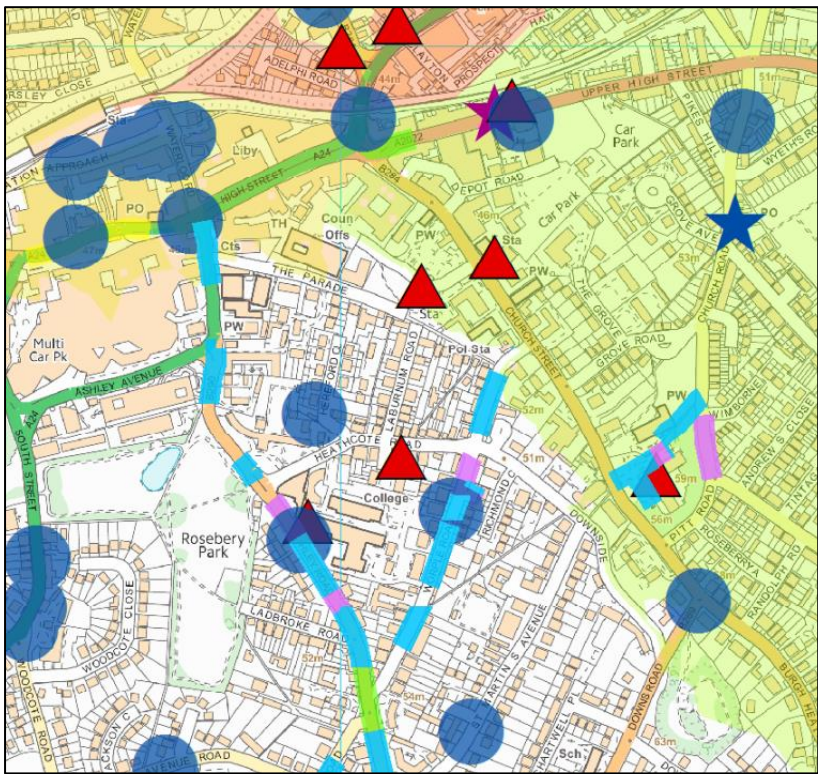
Legend	
	Epsom & Ewell Boundary
	Main Rivers
	Ordinary Watercourses
	SCC Highways Historic Flooding Incidents - indicative
	SCC Highways flood enquiries
	SCC Highways Internal Property Flooding Roads - indicative
	SCC Highways External Property Flooding Roads - indicative
EEBC 2007 Flooding	
	Flooding (External)
	Flooding (Internal)
	Groundwater Flood Incidents 2000, 2002 & 2014
Historic TW Sewer Flooding Incidents	
	1
	2
	3
	4
	5
	6
SCC Wetspot Published Status	
	Current - wetspot is an active flooding location
	Works are scheduled or works have been carried out and require confirmation of drainage effectiveness
	Works have reduced flood risk or no significant flooding in the last 3 years

The SFRA mapping⁸ indicates a record of groundwater flooding adjacent to the site. However, when the LLFA were contacted they outlined that they held no records of groundwater flooding in that location. No details have been identified what the event is that the SFRA refers to.

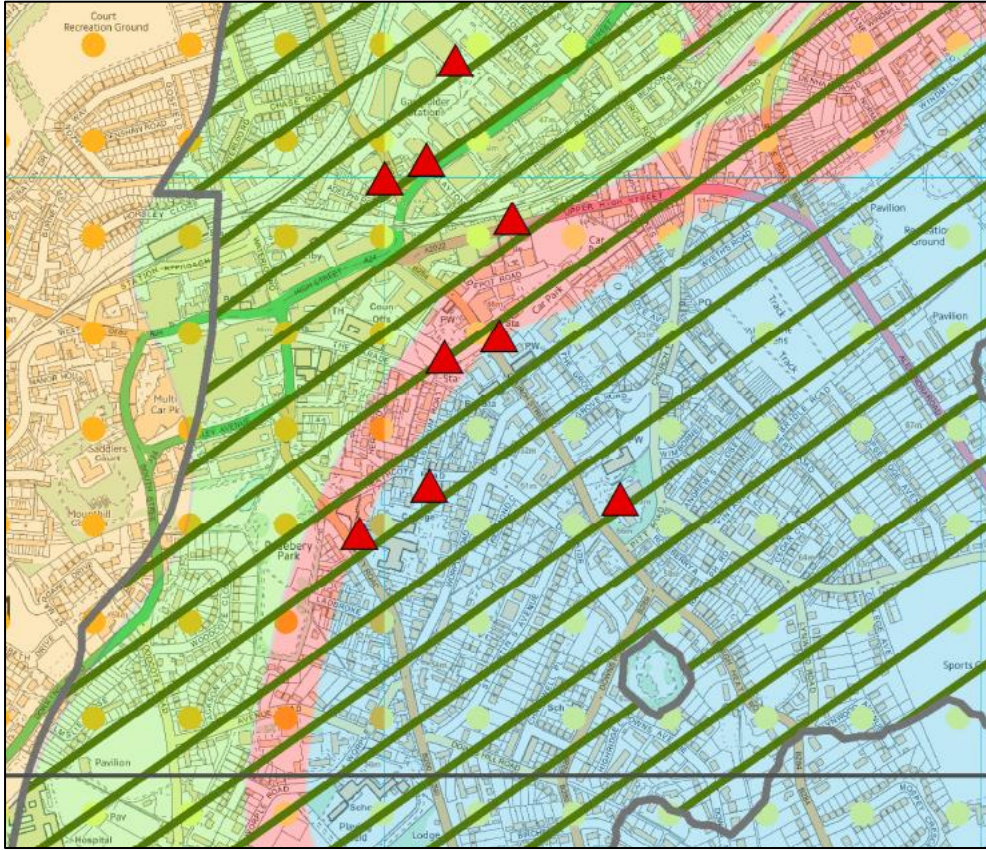
Jacob's **Groundwater Emergence Map(GEM)** is shown in **Figure 110** below. The diagonal shaded areas are the Groundwater Emergence Zone and the area around The Parade has $\geq 25\%$ risk of AStGWF (Areas Susceptible to Groundwater Flooding) shown as yellow dots. Richmond Council requires a Basement Screening Assessment as part of a Planning Application process - not as a Condition.

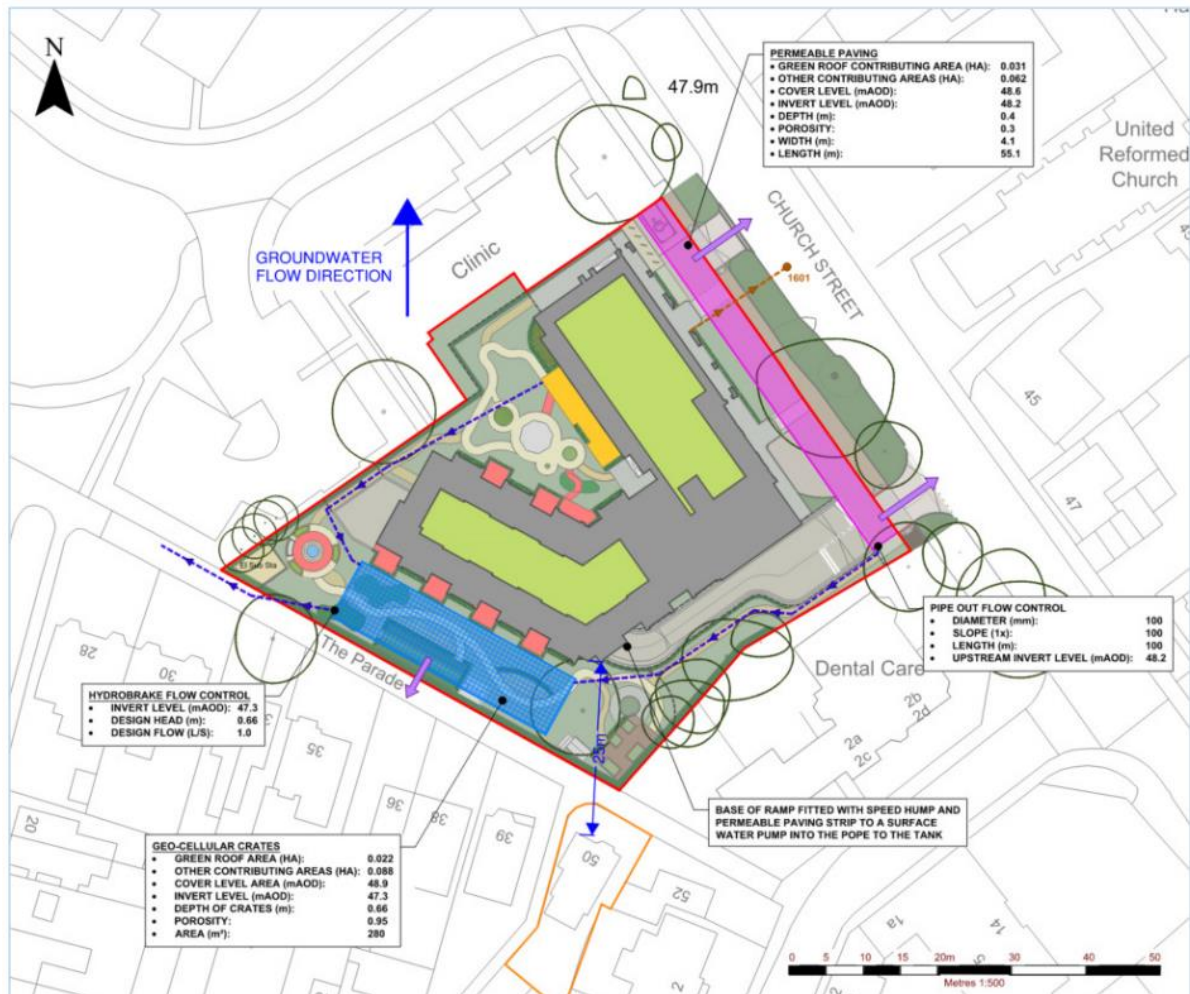
Figure 4: Site Context (Extract from Surface Water Drainage Strategy)

Care home proposal showing position of basement car park in dark grey (footprint of building) plus attenuation tank (in blue) located between the basement car park and The Parade. Also showing assumed groundwater flow direction and distance of proposed basement from our house. NB the attenuation tank is even closer than the basement car park.
