#### **BOURNE HALL LODGE**

This report sets out six potential options to consider the future use of Bourne Hall Lodge.

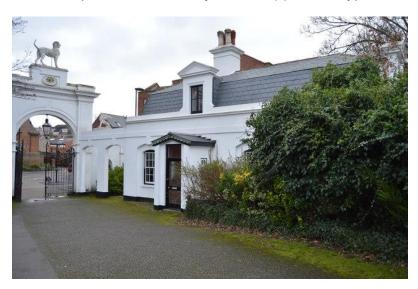
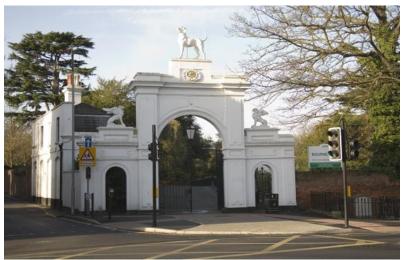
- 2.1 The Grade II listed Lodge is located at the corner of High Street and Spring Street and is attached to the Dog Gate entrance to Bourne Hall Park.
- 2.2 As shown in the photos below, it consists of a one storey building topped by a mansard roof with the Spring Street elevation forming part of the perimeter wall (with windows only on the upper storey).
